# Harrison Street, Accrington, BB5 ODT

New Home Inspection

Thursday, 23 February 2023

MDR Home Inspections

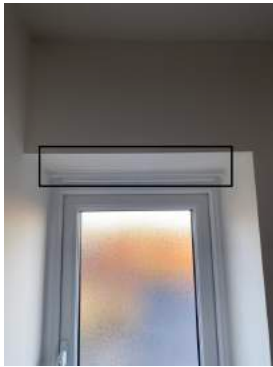
Bed One En Suite

Touch up discoloured marks to reveal at head of window.

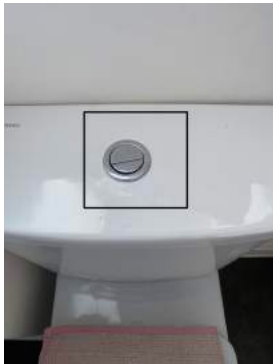
Bed One En Suite

Tighten toilet flush button. Loose to cistern currently.

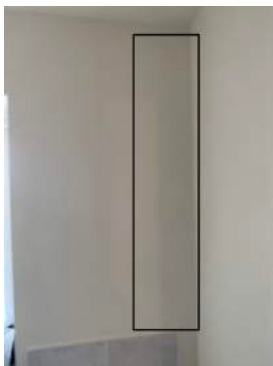
Bed One En Suite

Re roll corner wall line finish.

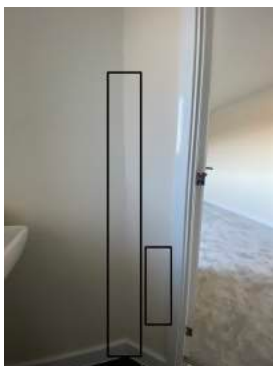
Bed One En Suite

Improve splay wall line finish as shown and ensure low level wall marks are also touched up.

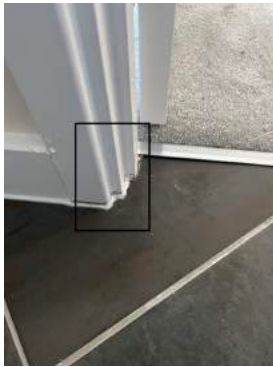
Bed One En Suite

Ensure base of door frame is decorate complete and complete mastic seal of door frame to tiled floor.

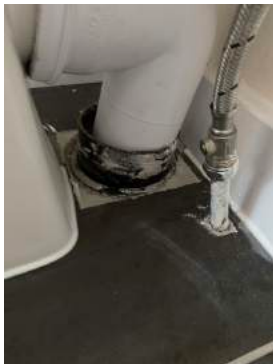
Bed One En Suite

Tidy grouting finish behind toilet around waste pipe.

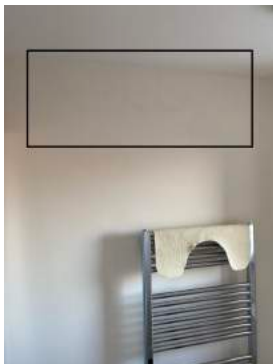
Bed One En Suite

External wall line stained above towel radiator. Plasterboard dabs showing through. Wall requires stain blocking and re roll of wall.

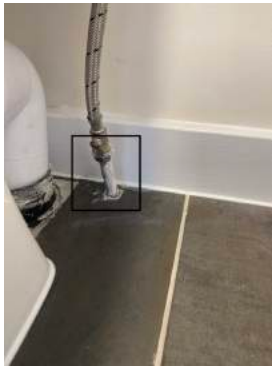
Bed One En Suite

Re paint toilet cold feed pipe. Not enough paint coverage.

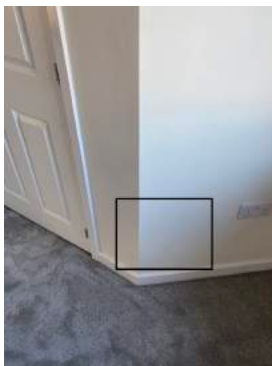
Bed One

Touch up wall face low level from scuff marks.

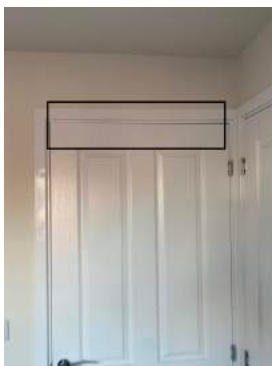
Bed One

Door margins to head of bedroom and en suite door not consistent.  
Correct.

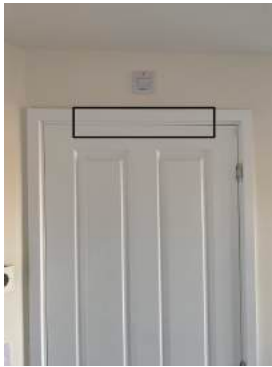
Bed One

Make good damage to head of architrave to en suite door and also countersink paslode nail next to this.

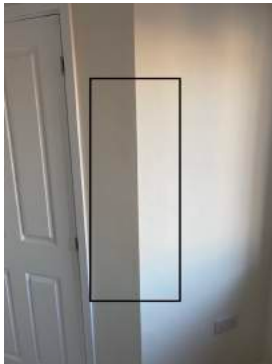
Bed One

Brush mark finish to splay wall untidy. Should be a rolled finish.

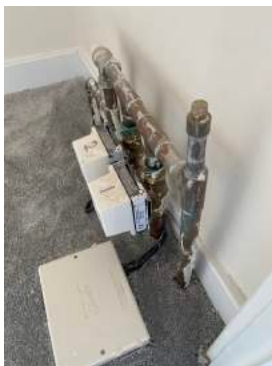
Bed One

Complete decoration of zone valve pipework within cupboard space.

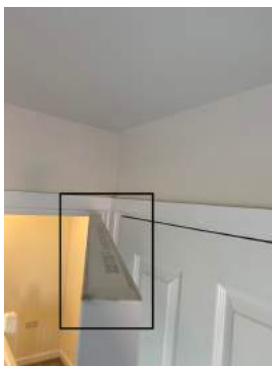
Bed One

Incomplete decoration to head of bedroom door. Ensure all heads of doors are decorated.

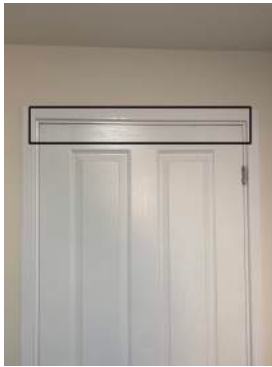
Bathroom

Improve finish to head of door face and also make good architrave finish to head of frame.

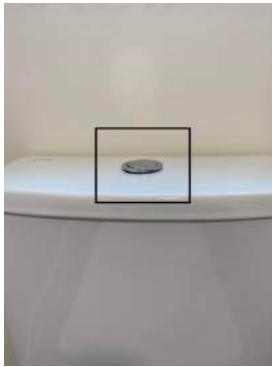
Bathroom

Cistern flush is not currently screwed down correctly. Requires tightening.

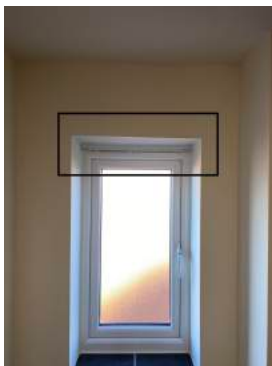
Bathroom

Window reveal is not straight to head of window. Requires levelling up.

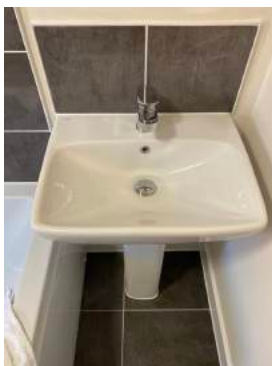
Bathroom

Wash basin currently not holding water. Requires attention.

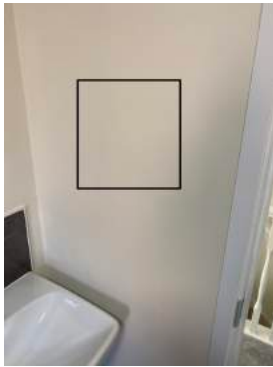
Bathroom

Touch up scuff marks to wall face as shown right side of wash basin.

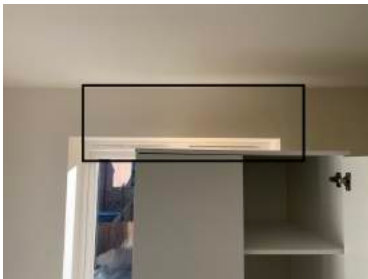
Bed Two

Ceiling to wall line junction not straight directly over window. Currently outside 4mm deflection tolerance permitted. Plaster finish rippled finish also above window to wall face to improve.

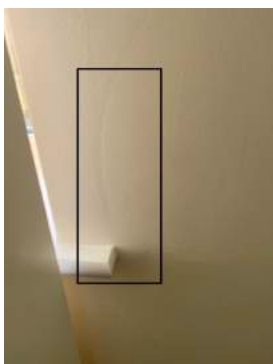
Bed Two

Gouge in wall finish above window cill right side of window. Improve plaster finish.

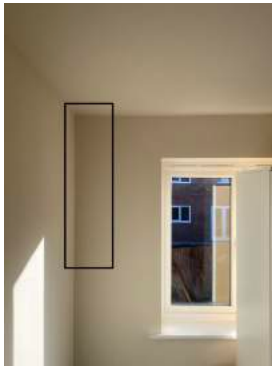
Bed Two

Discoloured corner wall line high level left side of window. Re roll wall face.

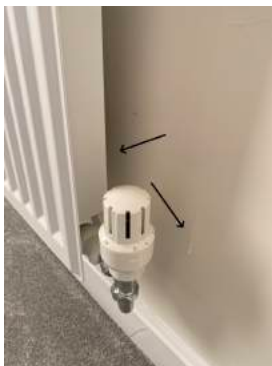
Bed Three

Ensure pencil marks are made good directly behind radiator and sand paint drip to wall line to same location right side of radiator.

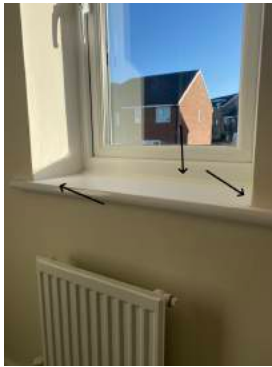
Bed Three

Messy finish of window cill to reveals and also to window frame as shown. Improve all areas.

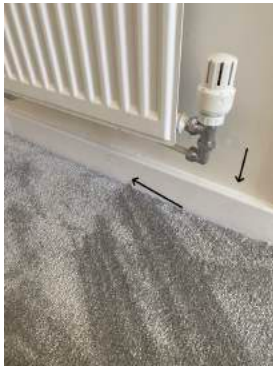
Landing

Untidy finish to skirting line directly below radiator. Re gloss skirting and tidy wall face above.

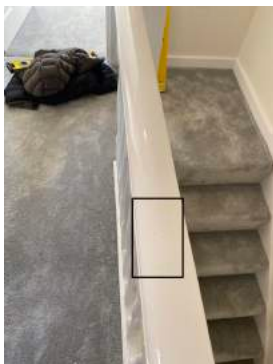
Landing

Hole within handrail as shown. Make good handrail face and suggest rub down and re gloss this.

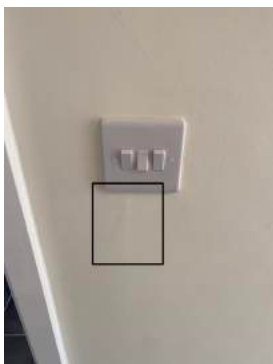
Landing

Lump within wall line finish below three gang switch. Level out wall face and re roll.

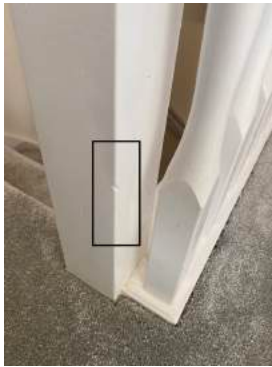
Landing

Dented corners of landing newel post. Make good.

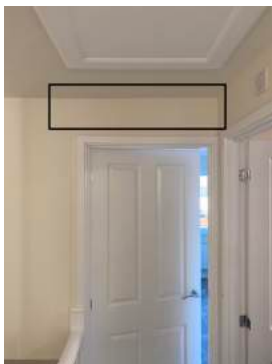
Landing

Ceiling to wall junction not currently straight over bedroom one door. Plaster fill/level wall to ceiling junction.

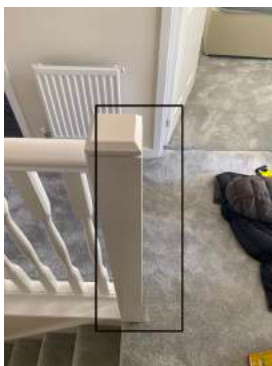
Landing newel post is leaning in excess of 10-15mm out of upright. Requires correction. Also ensure dowel holes are re filled and made good where handrail has been fixed into this.

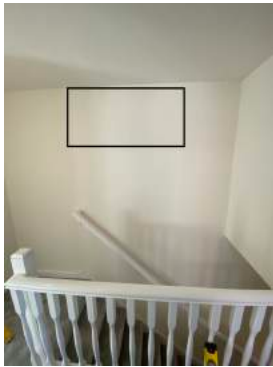
Stairs

Discoloured wall face high level to stairwell wall. Clean up.

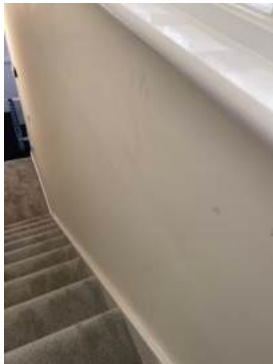
Stairwell

Dirty wall marks throughout stairwell to touch up.

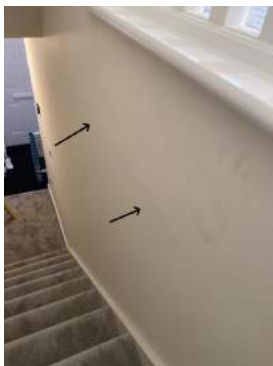
Stairwell

Hump within wall line as directed. Sand wall face and re roll wall face.

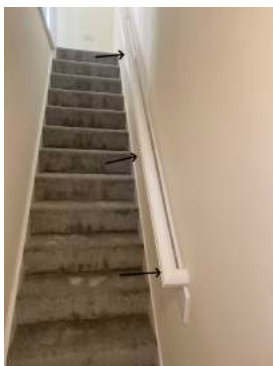
Stairwell

Handrail chipped paint finish and dented on bottom face of handrail.  
Make good and re gloss complete length of this.

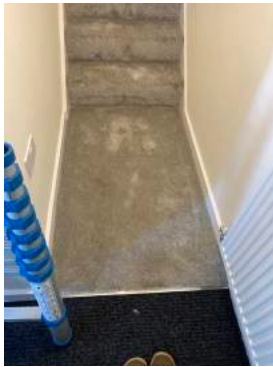
Hallway carpet damp from potential leak from radiator. Advise lift carpet, install dehumidifier to dry floor area out before re fitting carpet and employing carpet cleaning company to re clean affected areas.

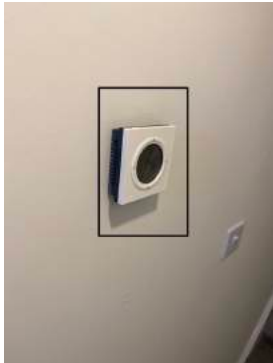
Hallway

Programmer unit not engaging with heating. Requires investigating and resolving.

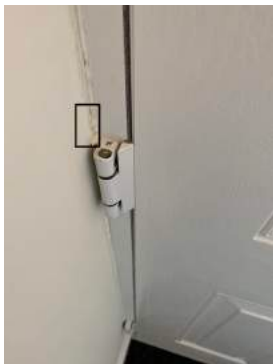
Hallway

Add cover cap to middle door hinge.

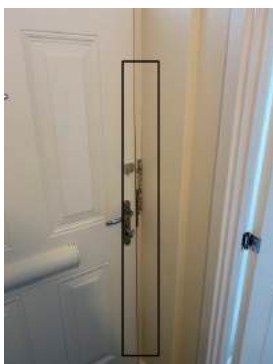
Hallway

Poor finish of reveal to external door frame. Right side. Requires mastic sealing.

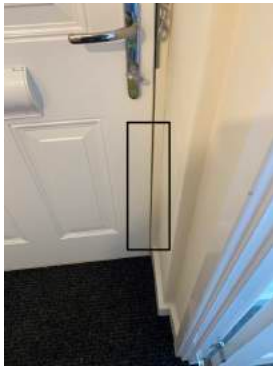
Hallway

Draft bleeding through between door frame and door low level. Adjust.

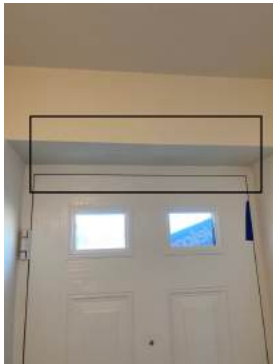
Hallway

Stained reveal to head of external door. Stain block and re roll.

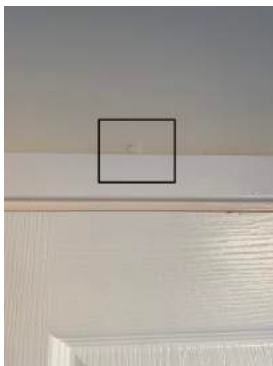
Living Room

Screw head on show above living room door frame. Countersink and refill/decorate.

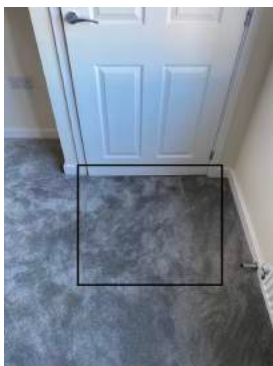
Living Room

Section of damp carpet in front of door. Same issue as hallway and same suggestion.

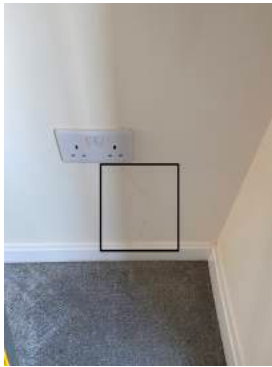
Living Room

Ensure all wall line marks are  
Touched up throughout the room where visible.

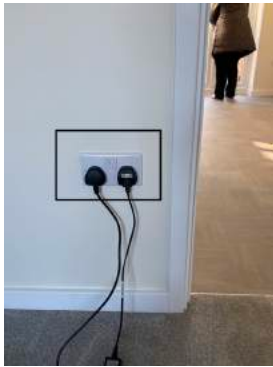
Living Room

Double socket not level to wall.

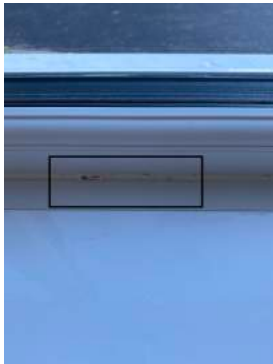
Living Room

Scuffed mastic seal to base of window frame. Centre of this.

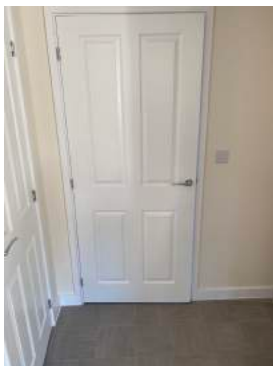
Kitchen door leading to living room requires planing down as this is currently catching the threshold bar and not allowing the door to latch.

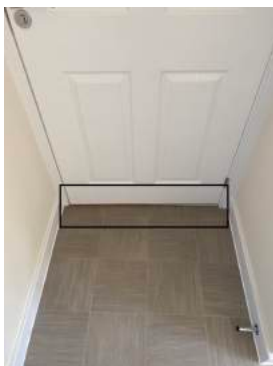
Cloakroom

Rough cut finish to base of cloakroom door. Sand and make good.

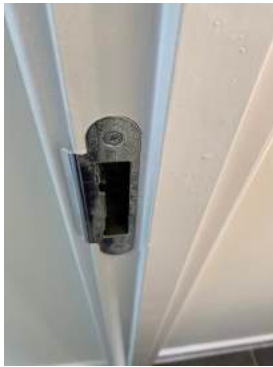
General

Paint on door furniture and hinges throughout the house. Advise re clean all door furniture and window frames.

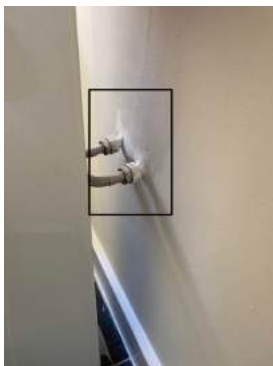
Cloakroom

Improve wall plaster finish around wash basin tails entering wall line.

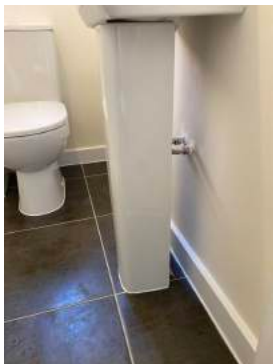
Cloakroom

Pedestal is not fitted square onto floor. Margin between pedestal and skirting not equal.

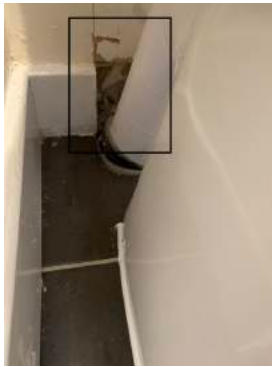
Cloakroom

Untidy skirting and floor/wall finish behind toilet waste pipe. Requires significant improvement.

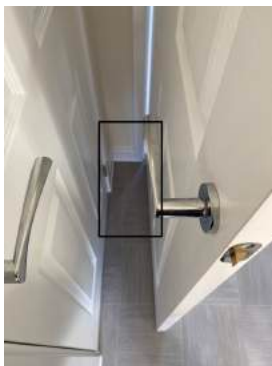
Kitchen

Consider adding door stop in behind door leading to living room to prevent handles of this and cupboard clashing.

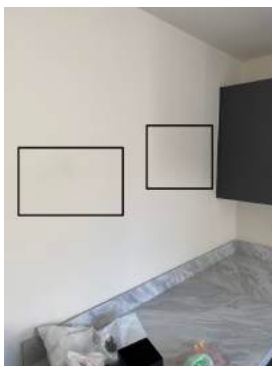
Kitchen

Dirty wall marks to remove as shown.

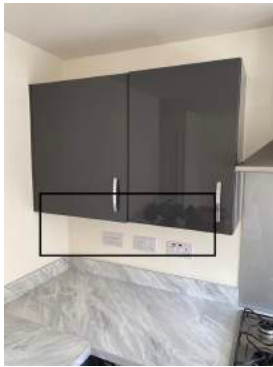
Kitchen

Bottom edges of wall unit doors are not aligned with each other.  
Requires correction.

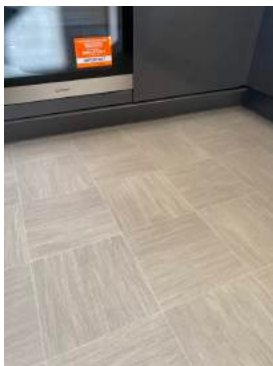
Kitchen plinths to be re sized following floor install.

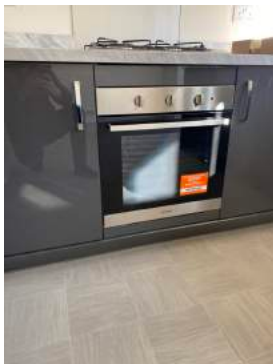
Kitchen

Isolation valve for gas carcass to hob currently stuck behind oven and  
not accessible in event of a leak. Relocate gas hob isolation valve to base  
unit to side of oven unit.

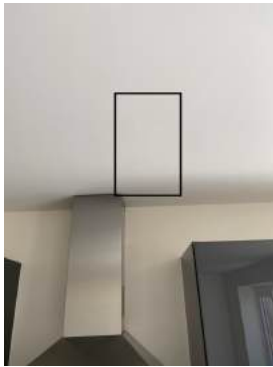
Kitchen

Ridges to ceiling finish in front of extract hood. Make good ceiling area.

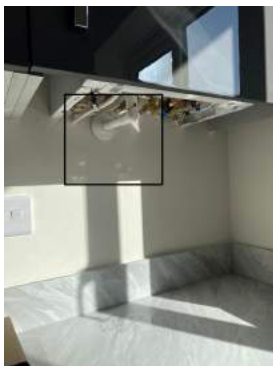
Kitchen

Leak currently on condensate pipe below boiler.

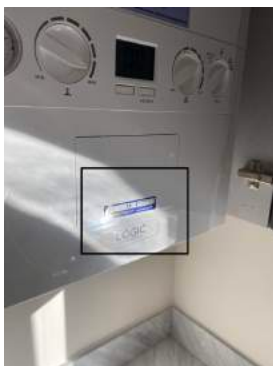
Kitchen

Complete labelling of inhibitor to boiler Inuit. Date this was added.

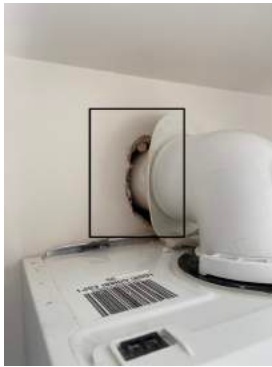
Kitchen

Cement fill and plaster patch hole around flue terminal where this enters the wall.

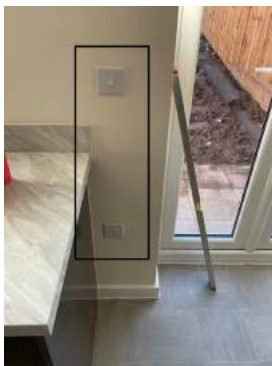
Kitchen sockets are not aligned with each other. Looks poor.

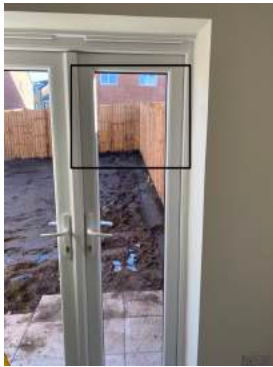
Kitchen

Scratch mark to patio door glass.

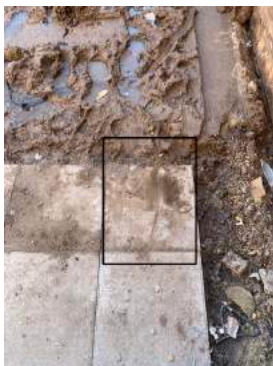
External Works Rear Elevation

Broken patio slab to be changed.

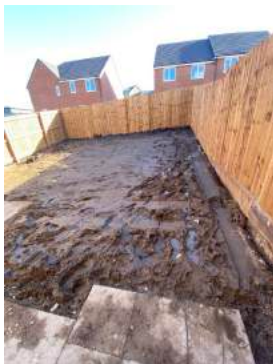
External Works Rear Garden

Compacted mud will need removing and replacing with dry topsoil to allow garden to drain. With gradient of garden, can developer confirm that some drainage facility has been installed to accommodate water run off from rear boundary fence to patio slabs. Requires installing to allow water to drain away from house.

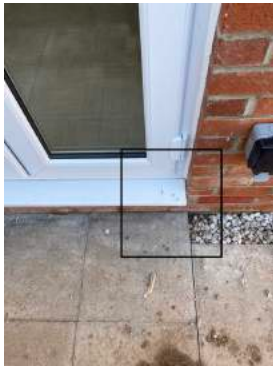
External Works Rear Elevation

Damaged patio door cill right side. Cracked and also missing end cap to cill.

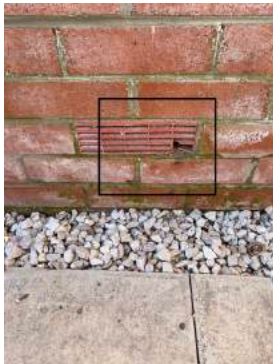
External Works Rear Elevation

Replace damaged telescopic vent to rear of house.

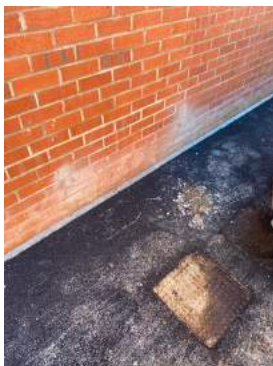
External Works Side Elevation

Jet wash elevation wall from concrete dust and mortar staining.

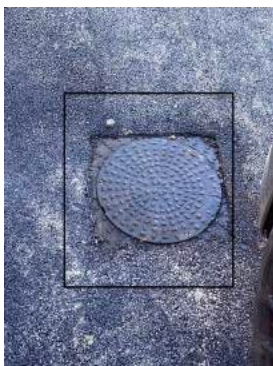
External Works Side Elevation

Driveway finish not consistent with finish of tarmac around manhole covers. Manhole covers have not been raised up to level of tarmac on driveway in which driveway next to property is. Not well presented and potentially a slight trip hazard.

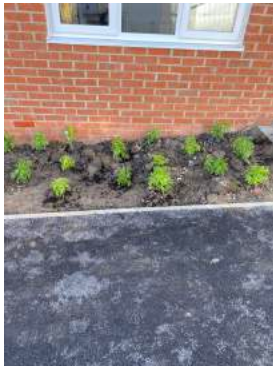
External Works Front Elevation

Complete bark to landscaped area.

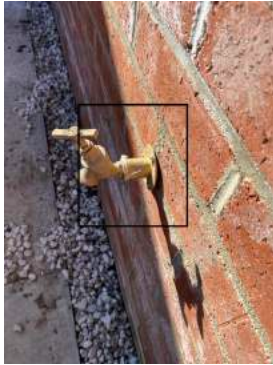
External Works Rear Elevation

Outside tap back plate not installed flat against house wall face. Correct.
