# Harrison Street, Accrington, BB5 ODT

New Home Inspection

Thursday, 23 February 2023

MDR Home Inspections

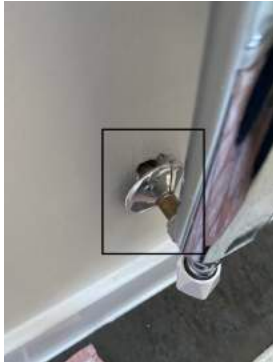
Bed One En Suite

Plaster patch hole in wall line where towel radiator tails enter before refitting rosettes. Also complete decoration of towel radiator tails.

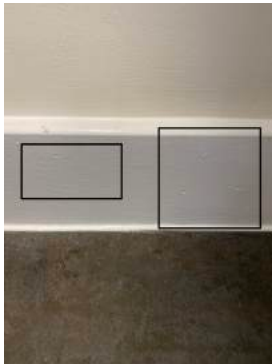
Bed One En Suite

Paslode nail holes where filled have sunk back into skirting. Require re preparation of skirting and redecoration of this.

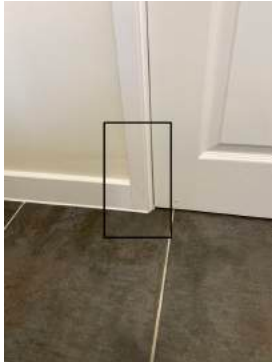
Bathroom

Architrave flashing left side of door where tile is connects to skirting.

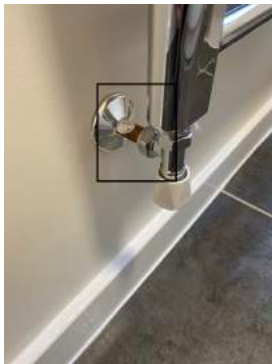
Bathroom

Complete decoration of towel radiator tails.

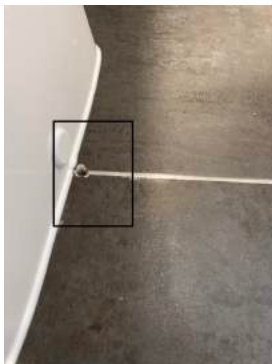
Bathroom

Toilet holes originally drilled in wrong location. Requires attention as enamel face to floor tile is also chipped.

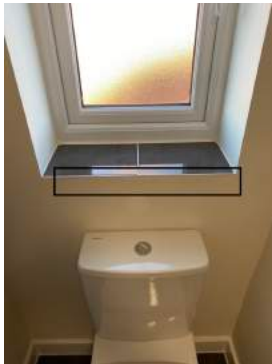
Bathroom

Stained wall line finish below window ledge. Redecorate this area.

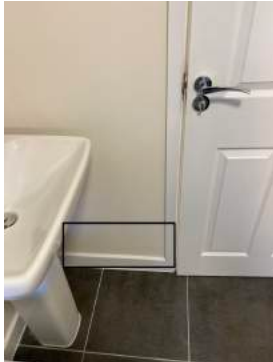
Bathroom

Plasterboard finish is dented above skirting line left side of door. Plaster fill out dented wall finish and re roll wall face.

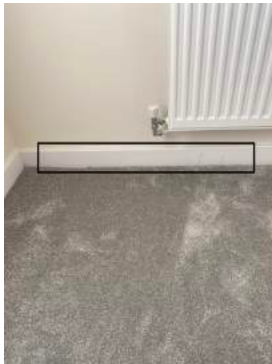
Bed Three

Top edge of skirting cracked following carpet fitting. Re caulk top edge and redecorate.

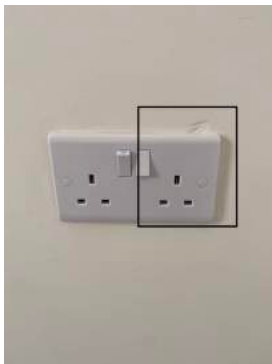
Bed Three

Untidy finish of plaster around external wall double socket. Improve wall face.

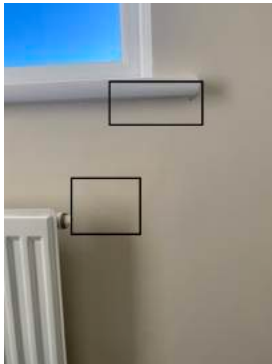
Bed Three

Untidy plaster finish to wall face as highlighted.

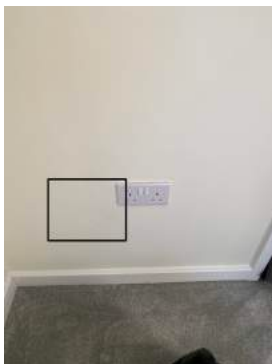
Bed Three

Not enough paint coverage to wall face left side of double socket on landing wall. Re roll wall face.

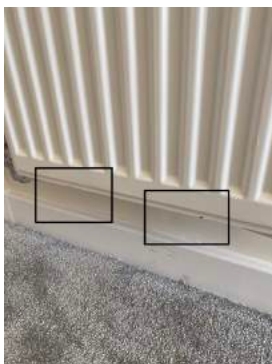
Landing

Untidy finish to skirting line directly below radiator. Re gloss skirting and tidy wall face above.

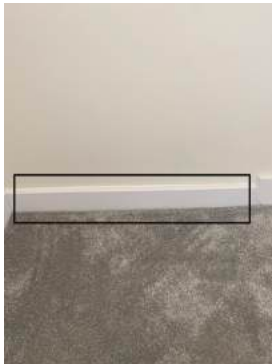
Landing

Preparation of landing skirting not good enough and skirting has also cracked following carpet installing. Make good.

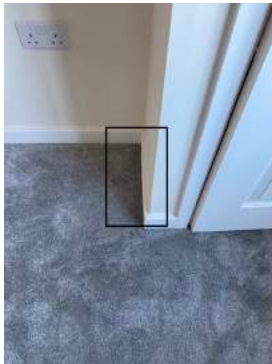
Living Room

Bowed skirting on return section of wall. Correct.

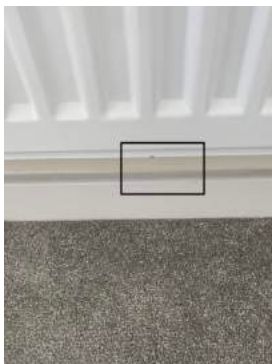
Living Room

Base of living room radiator chipped enamel finish. Make good.

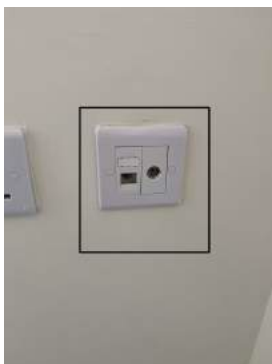
Living room

Broken tv/bt face plate. Change over.

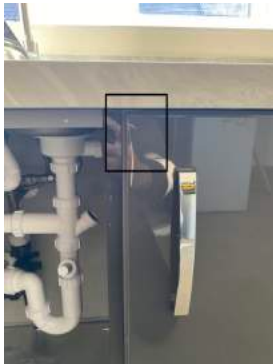
Kitchen

Damage to base unit door next to sink unit. Change.

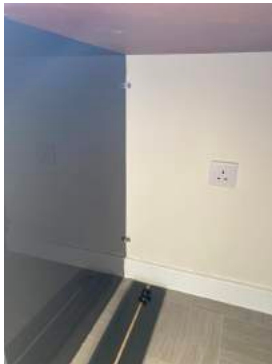
Kitchen sockets are not aligned with each other. Looks poor.
